IMPROVEMENTS OF THE SAFETY ENVIRONMENT FOR THE UCN-KICKER MAGNET

U. Rohrer, R. Dölling

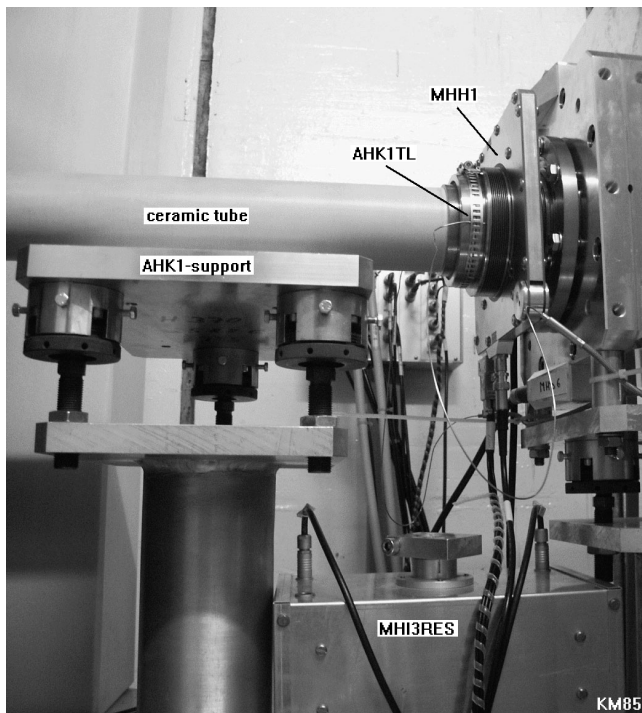
Fig. 1: Photo of the ceramic tube with the 4-segment (l/r/o/u) halo monitor (MH1), the thermo couples (AHK1TL/R) on each side of the entrance flange and the ionisation chamber (MHI3RES) below the support for the kicker magnet (AHK1, not in place).

During 2004 three different types of diagnostic elements were mounted near the newly installed ceramic tube of the kicker magnet (Fig. 1):

- 1) Two thermo-couples at the entrance of the tube, one at the left and one at the right side of it. The interlock levels are set to 40 °C. The normal operational temperature is not significantly higher than the ambient temperature of 30 °C.

- 2) An additional dedicated ionisation chamber is placed underneath the kicker magnet as close to it as possible. About the usefulness of ionisation chambers for protecting the 590 MeV proton channel see [3] and [4]. At normal operating conditions, the signal from this chamber is in the range of 5 to 30 nA at 1.8 mA proton beam intensity. The interlock level is set at 100 nA.

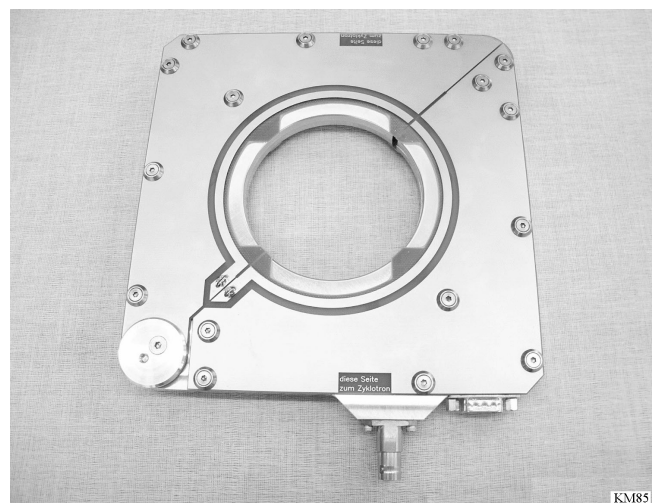
Fig. 2: halo-monitor MHH1 (to be clamped over an indentation of the beam tube, e.g. bellows) initially designed for the new PROSCAN Facility at PSI (see [5], [6]). Well visible are the high voltage electrodes of the 4 segments (the inner diameter of the device is 82 mm), which are hit directly by protons traversing the beam tube at large radii up to about 50 mm (halo).

- 3) Application of a newly developed halo monitor (see [5], [6]) for the first time with the 590 MeV proton beam. Unlike ionisation chambers, this device monitors only the losses due to the halo of the proton beam at the location where the beam traverses its 4 active volumes (Fig. 2). Therefore it is very sensitive to miss-steering of the beam. The interlock levels of all 4 segments are set to 100 nA. Measured currents are usually not exceeding 5 nA (Fig. 3). There is always a higher signal on the left than on the right side (low energy tail of the halo).

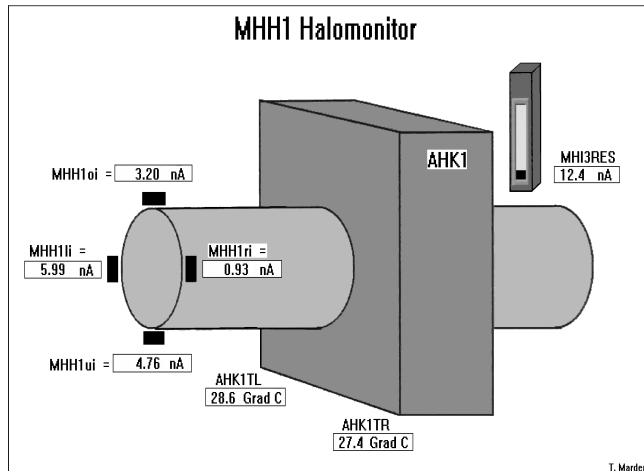
Fig. 3: Operator's synoptic screen display with the measured currents at the 4 segments of the halo monitor (MHH1l/r/o/ui), the 2 temperatures (AHK1TL/R) at the entrance of the ceramic tube and the current signal from the ionisation chamber (MHH1RES) positioned underneath the kicker magnet (AHK1).

A special synoptic display for the operator's console shows continuously all the measured signals of these 3 diagnostic devices (Fig. 3). Therefore via some tuning it is possible to minimize the beam losses in this region of the proton beam line. In case of a misguided beam, the interlock system will turn off the beam before any damage to the ceramic tube will happen.

Weeks of smooth HE-production at 1.85 mA showed, that the newly installed diagnostic elements to protect the kicker tube work reliably. Additionally, with the help of the 'MHH1 halo monitor synoptic display' (see Fig. 3) the operation crew can reduce the losses in the vicinity of the kicker magnet to minimal values. This is

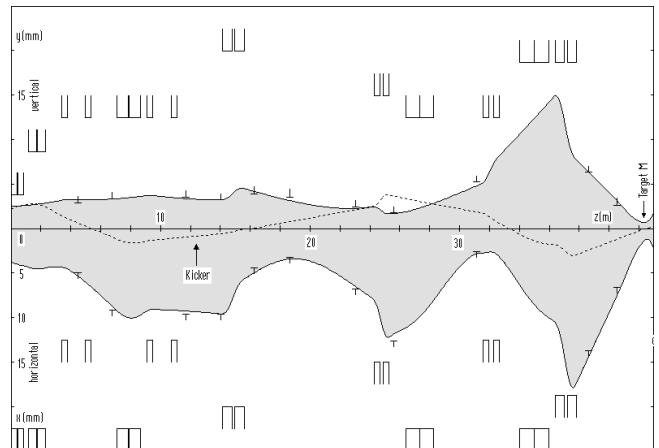
Fig. 4: The 2σ beam envelope of the newly adapted optics for the proton beam between the extraction of the 590 MeV Ring Cyclotron and Target M. The 2σ half-width in x at the location of the kicker is around 10 mm. The measured 2σ beam profile half-widths are indicated as T-symbols. The fit of the beam envelope to these data was done with the program Transport [7]. All drawn magnet aperture dimensions are scaled by a factor of 0.25. The dotted line represents the 0.1 % dispersion trajectory.

After reinstalling the ceramic beam tube with the new diagnostic elements in mid 2004, the monitored losses at this location exceeded the tolerable values by far. The reason is the constraint caused by the ceramic tube aperture with only 58.5 mm inner diameter compared to 100 mm with a standard vacuum tube. Even after a considerable tuning effort the losses could not be reduced to a satisfying level. Therefore it was decided to change the optics by lessening the width in x from around $4\sigma = 25$ mm to less than 20 mm without modifying the envelope near the target M (Transport envelope fit, see Fig. 4 and [7]). This modification has the consequence that the losses during DC-splitter operation for biomedical applications are typically 20 % higher. But this trade-off is tolerable because of the low duty-factor of this beam production mode. With the new optics the x-width (4σ) of the beam at the kicker position varies between 15 and 20 mm depending on the accelerator setup.
